RE: Remedial Action Progress Report No. 15 for the Industrial #1 Redevelopment Area
Portion of the Former General Motors (GM) Linden Assembly Plant, 1016 West Edgar
Road, Linden, Union County, New Jersey 07036; DUK059.701.0141.

This letter constitutes Remedial Action Progress Report No. 15 for the Industrial #1 Redevelopment Area. Hull & Associates, Inc. (Hull) has prepared this report on behalf of Linden Development LLC (Linden Development) to summarize remedial activities completed on the Site between March 1, 2013 and May 31, 2013.

Quarterly Report No. 15 for Industrial #1 Redevelopment Area
Former GM Linden Assembly Plant

Quarterly Report No. 15 for Industrial #1 Redevelopment Area
Attachment B
Photographs of Basement Structure Encountered May 2013

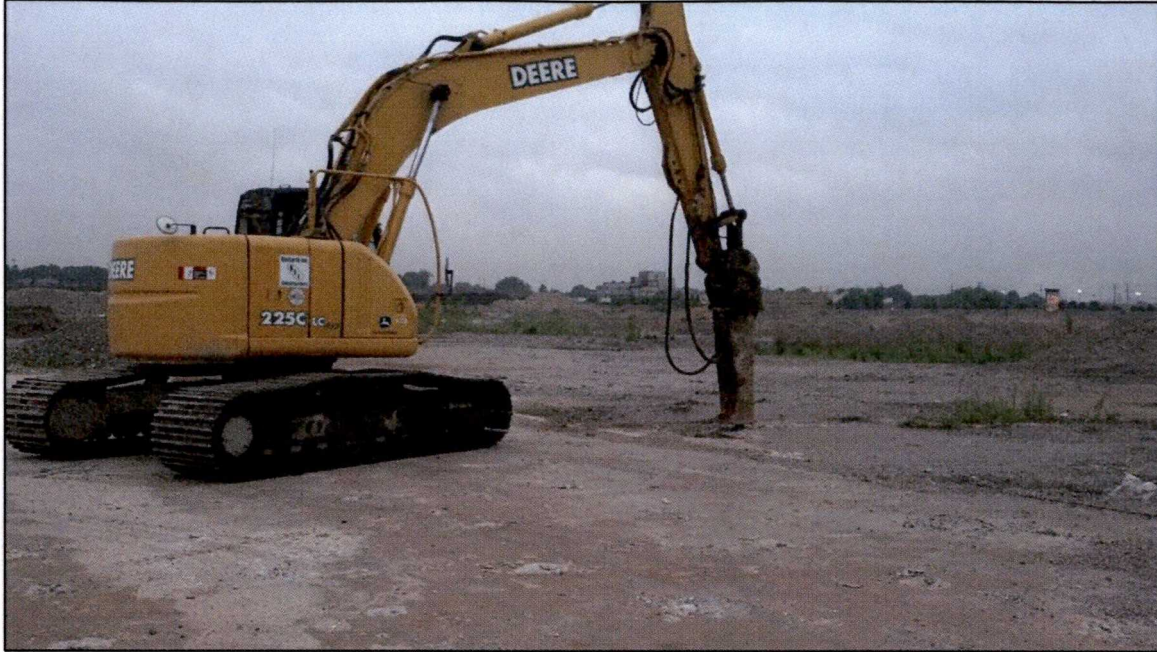
PHOTO 1 – Piercing the existing slab with the pneumatic hammer.

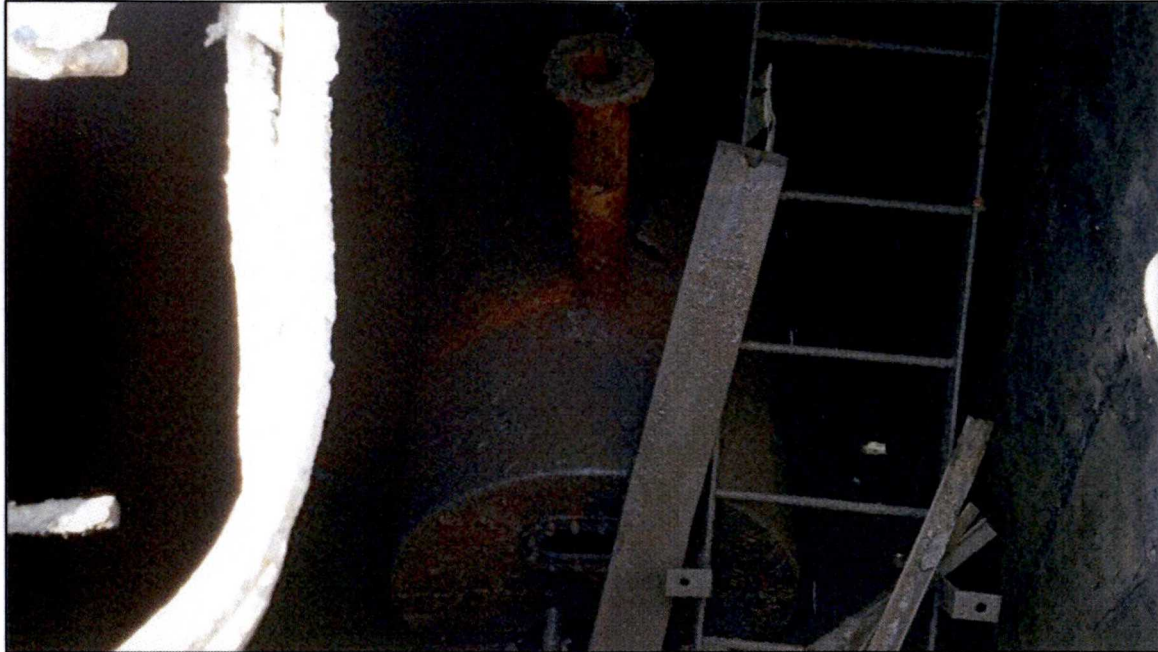
PHOTO 3 – Scrapped tank and ladder in basement during water extraction

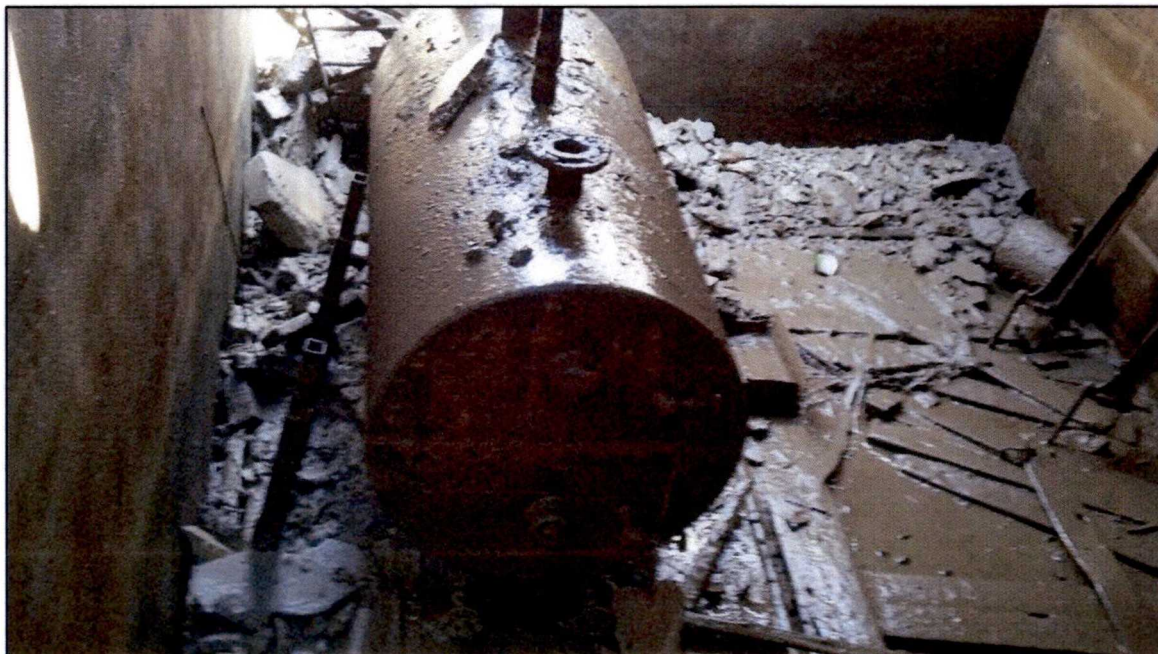
PHOTO 4 – Scrapped tank in basement following water extraction

water, the tank did not contain substances of concern, as no significantly elevated concentrations were detected. In addition, the floor and walls of the basement structure were observed to be free from staining or other evidence of impact. The basement structure was subsequently backfilled with onsite structural fill to match the surrounding grade. Pictures of the structure, steel tank and backfilling are provided in Attachment B.

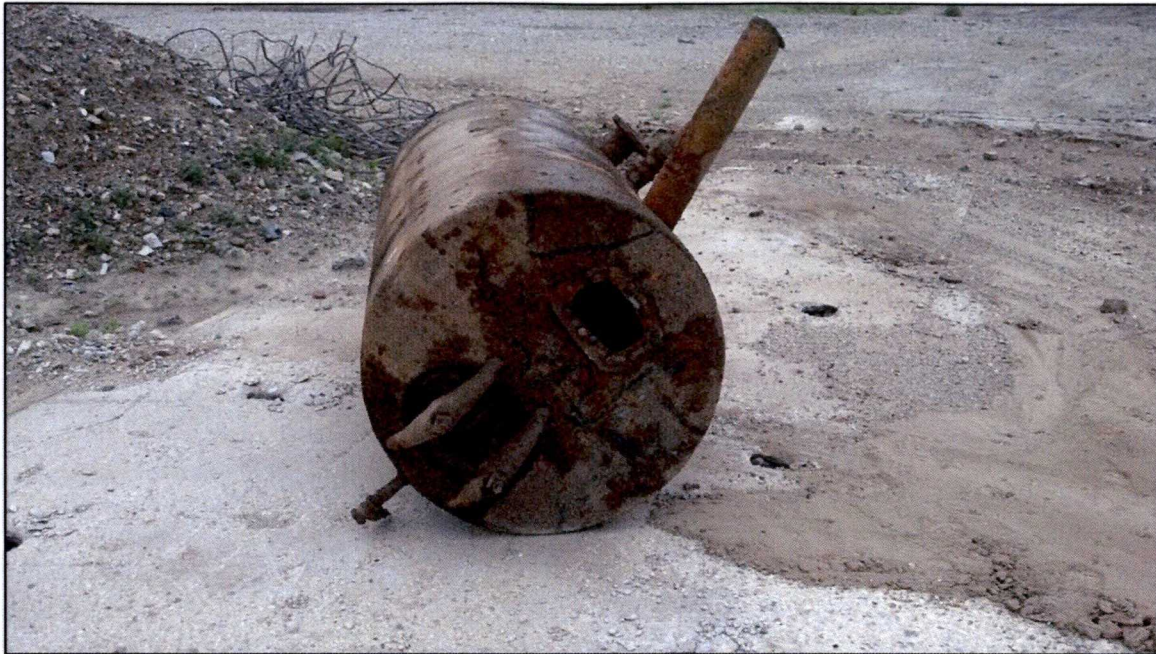
PHOTO 5 – Scrapped tank removed from basement; note the hole intentionally cut into the end of the tank at some point in the past.

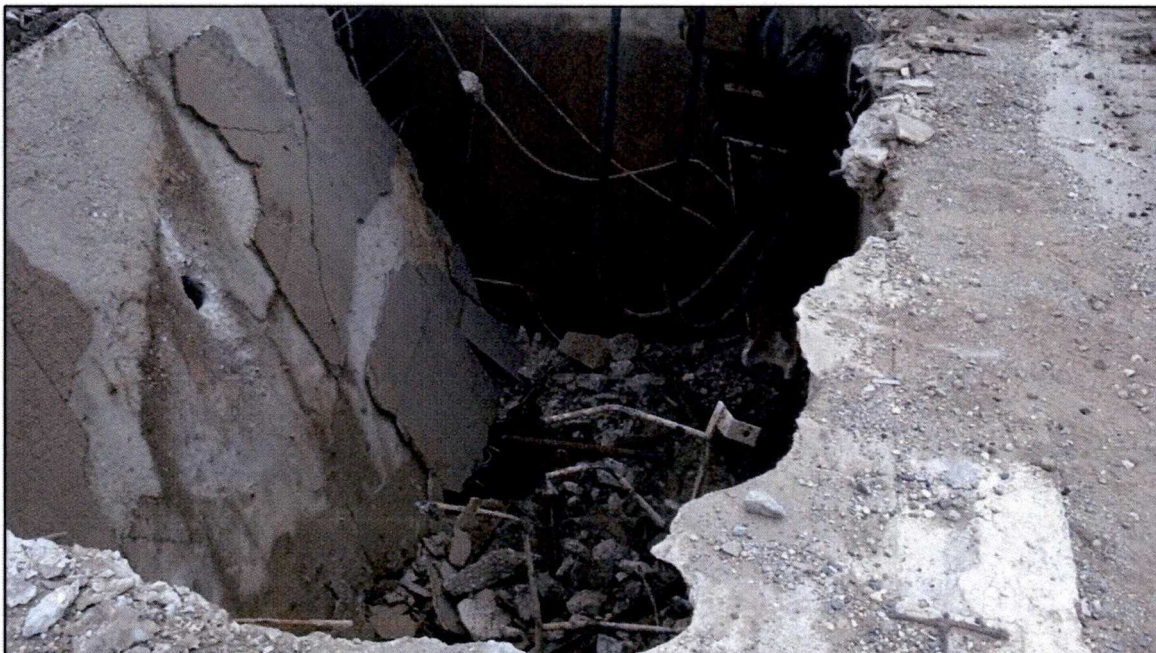
PHOTO 6 – Pneumatic hammer piercing floor of basement; note concrete slab (basement ceiling) now sitting in the basement.

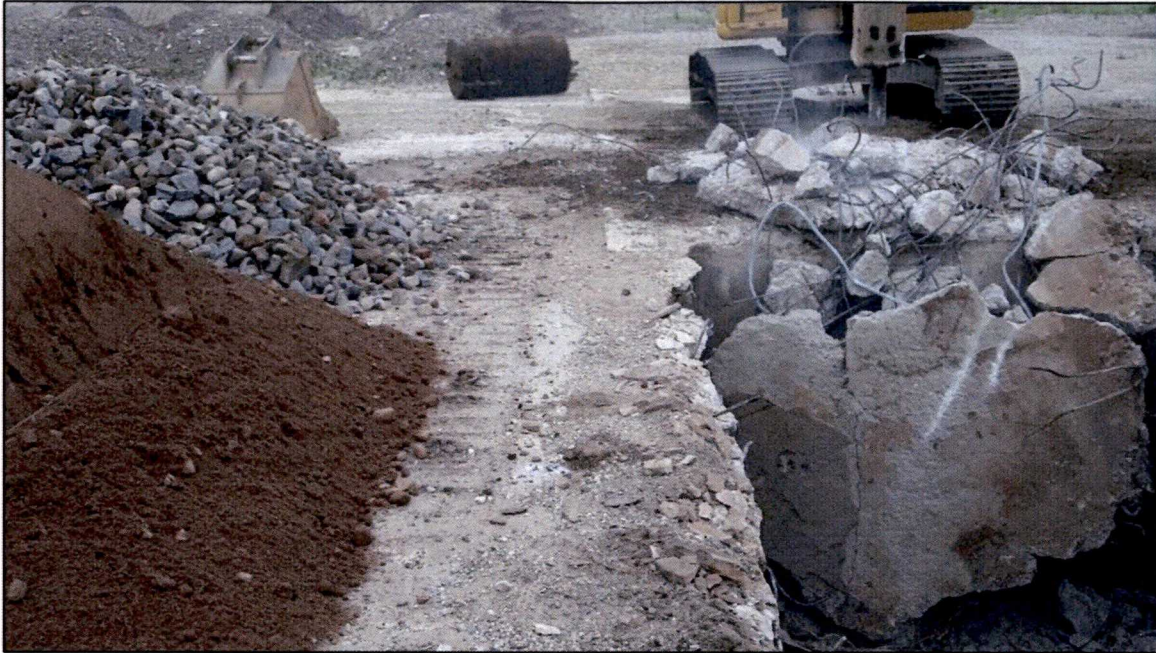
PHOTO 7 – Pneumatic hammer breaking concrete slab (basement ceiling) for reuse as structural fill; note structural fill stockpiles.

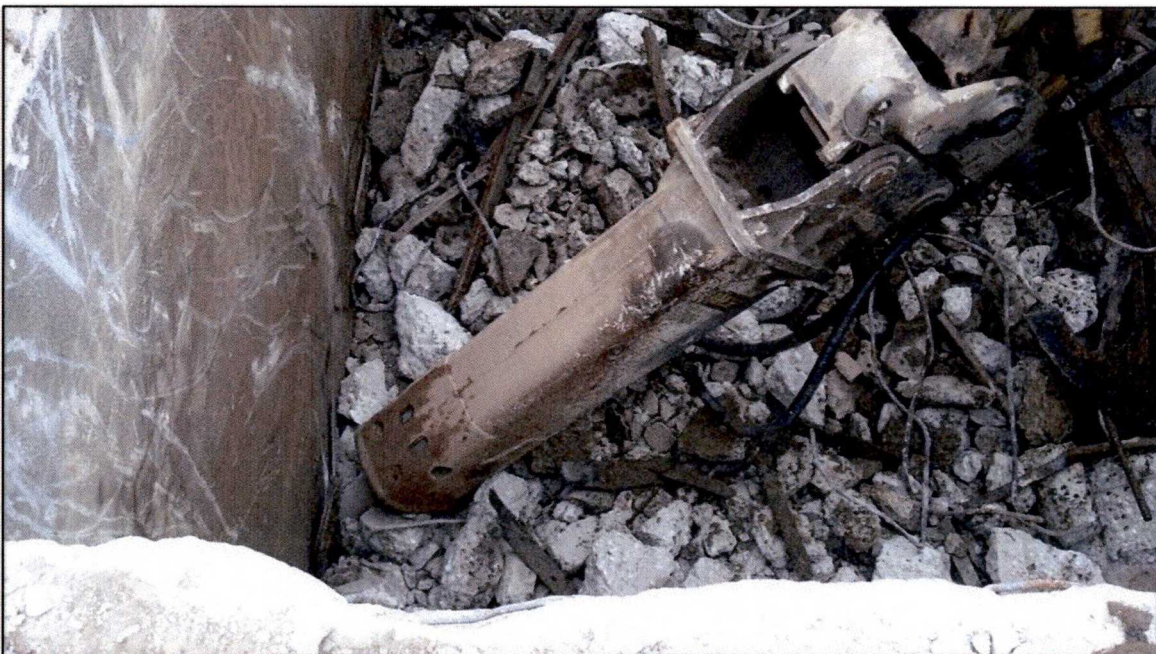
PHOTO 8 – Pneumatic hammer piercing floor of basement.

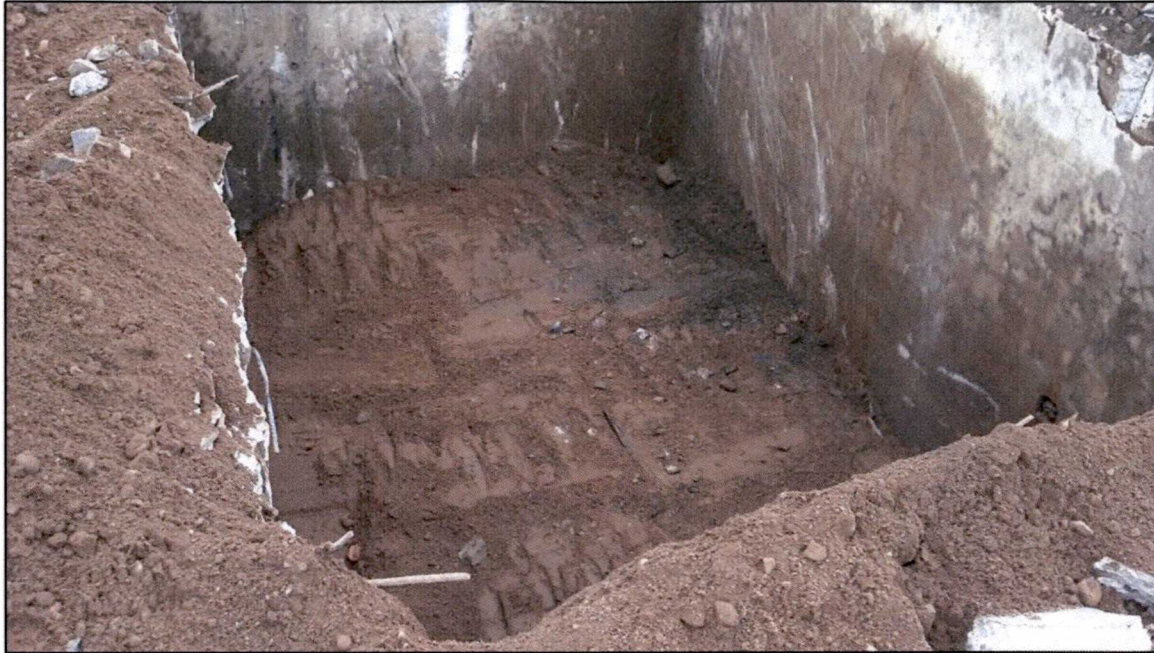
PHOTO 9 – Basement structure partially backfilled.
